Bay + Area Property Developers
327 Waverly Street
Palo Alto, California 94301

**PHASE I ENVIRONMENTAL SITE ASSESSMENT
PARCELS 428-61-1 AND 428-61-27
HAYWARD, CALIFORNIA**

AUGUST 6, 2015

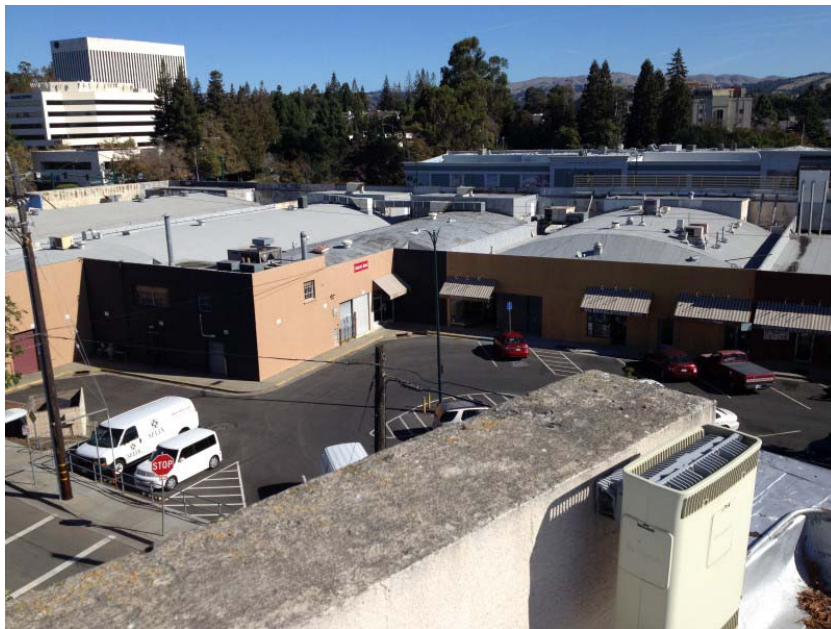
Photo 1.
View looking northeast from subject property. Selix Formalwear facility is visible across Maple Court. Photograph taken on October 21, 2014.

- **22401-22487 Foothill Boulevard (Selix Formal Wear)**, is located approximately 125 feet northeast of the subject property. The site is currently overseen by RWQCB (GeoTracker, 2014). In 2013-2014, investigation indicated that PCE and TCE were detected in soil gas beneath the building at concentrations exceeding ESLs for commercial land use. Based on the reported investigation results, the RWQCB requested preparation of a RAW to address the elevated soil gas concentrations that present a potential health risk beneath the building; the RWQCB also concurred that groundwater was not impacted significantly and no further groundwater investigation was required. Lateral definition of VOC-affected soil gas has not been conducted;

- **22401-22487 Foothill Boulevard (Selix Formal Wear):** Based on elevated PCE-affected soil gas concentrations detected at on- and off-site (i.e., detected at the subject property during the 2014 limited subsurface characterization), the documented release of dry cleaning solvents has encroached onto the subject property. The elevated concentrations of PCE detected in soil gas represent a vapor intrusion concern (VIC), and constitutes a REC;

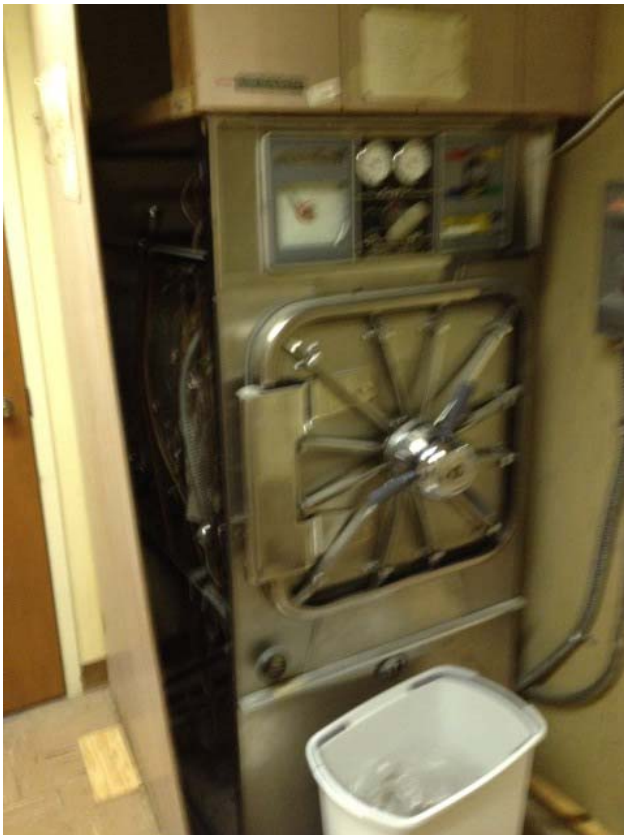
Photo 2.
Sterilizer machine located in basement of four-story medical building. Photograph taken on October 21, 2014.

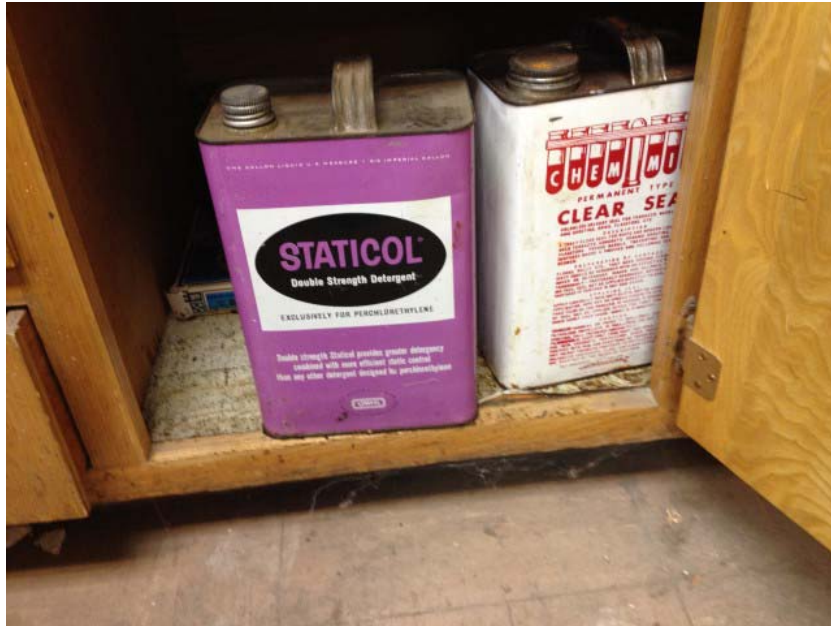
Photo 1.
View of chemical storage (dry cleaning detergent) in maintenance workshop in basement. Photograph taken on October 21, 2014.

Observed chemical use and storage is described in Section 6.0, above.

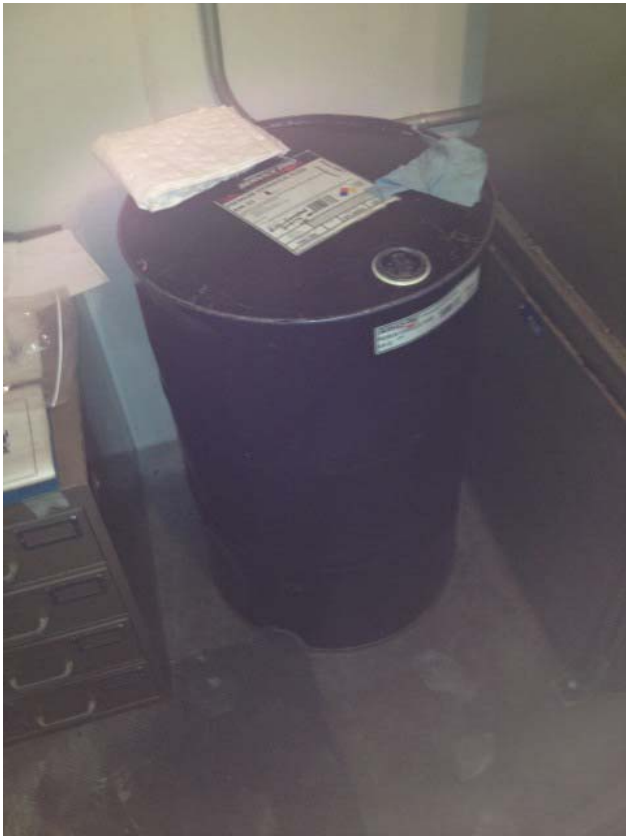
13

Three elevator machine rooms in the basement were inspected. A drum of hydraulic oil was observed in one elevator room (Plate 14, Photo 1). Evidence of leakage or spills of hydraulic fluid within the elevator machine room was observed in each location (Plate 12, Photo 1; Plate 14, Photo 2; and Plate 23, Photo 1).

Photo 1.
View of hydraulic oil stored in basement-level elevator machine room. Photograph taken on October 21, 2014.

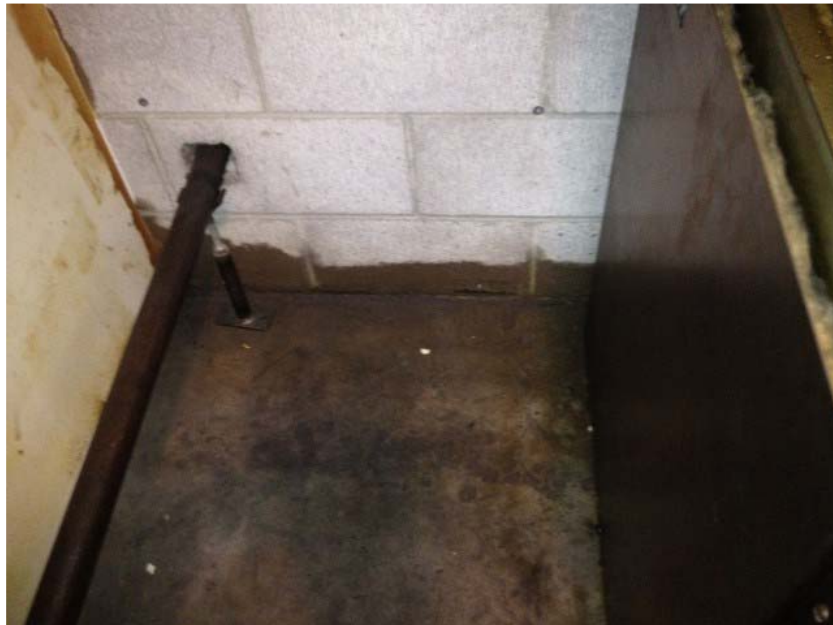
Photo 2.
View of concrete floor with apparent staining inside basement-level elevator machine room. Photograph taken on October 21, 2014.

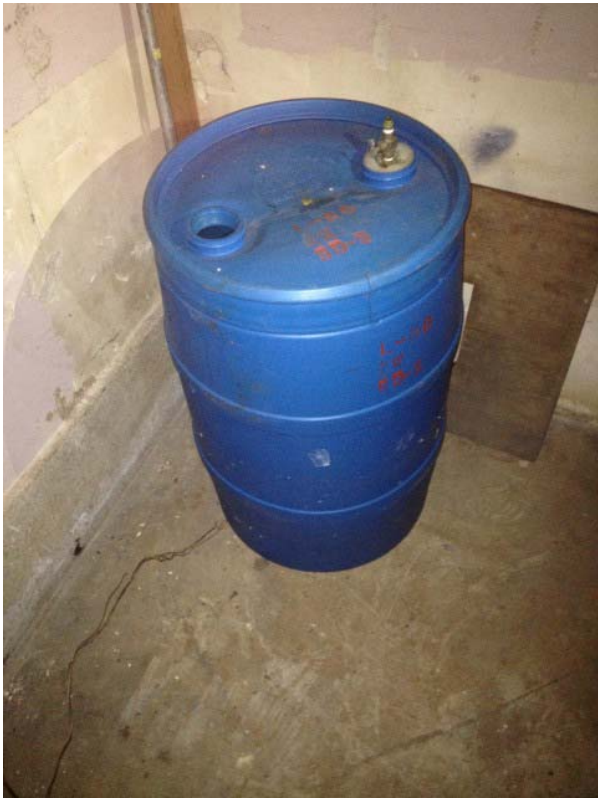
Photo 1.
View of 55-gallon drum in basement containing unknown material. Photograph taken on October 21, 2014.

- Secondary containment was not present for the 55-gallon drum of hydraulic oil, and the unlabeled 55-gallon drum located in the basement level of the building were stored on the concrete floor. Secondary containment or appropriate offsite disposal for these materials is recommended;

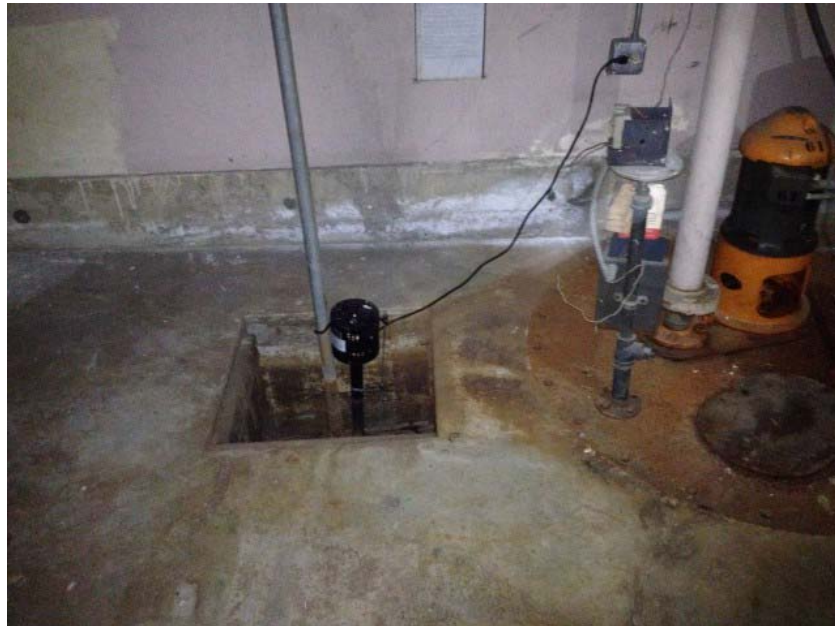
Used fluorescent lights were observed in a storage closet in the basement (Plate 21, Photo 1). Several shallow sumps were observed in basement areas (Plate 16, Photo 2). No concerns were noted.

Photo 2.
View of sump and associated pump in basement. Photograph taken on October 21, 2014.

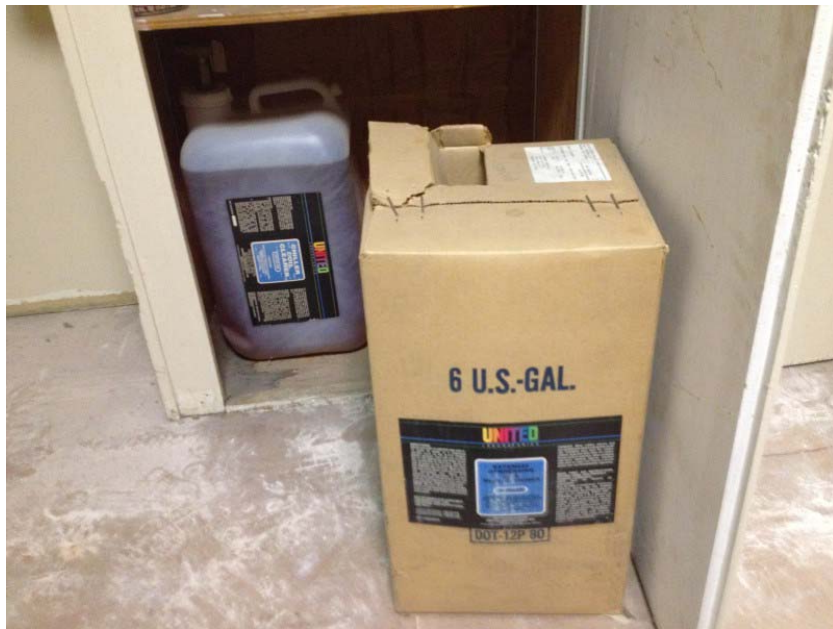
16

PES inspected a maintenance workshop in the basement area of the 22455 Maple Court structure (Plate 13, Photo 2). Small quantities of petroleum-based solvents, glues, thinners, and refrigerant coil cleaning chemicals were observed stored in wooden shelves. A 1-gallon can of Staticol (a detergent utilized in PCE-based dry cleaning operations) was observed (Plate 13, Photo 1). No dry cleaning solvents (e.g., PCE) or dry cleaning units were observed.

Photo 1.
View of chiller coil cleaner chemicals stored in maintenance workshop area.
Photograph taken on October 21, 2014.

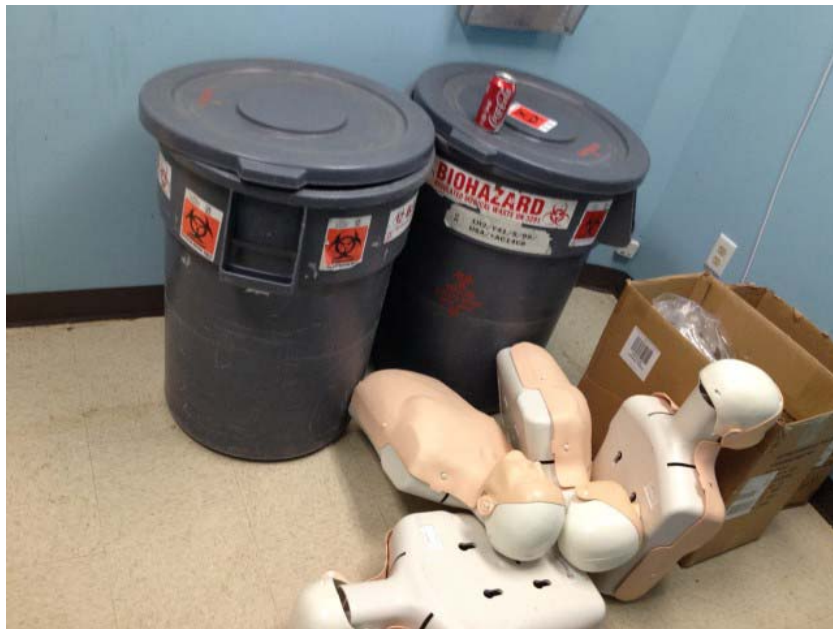
17

Photo 1.
View of biohazard storage area inside former medical college space.
Photograph taken on October 21, 2014.

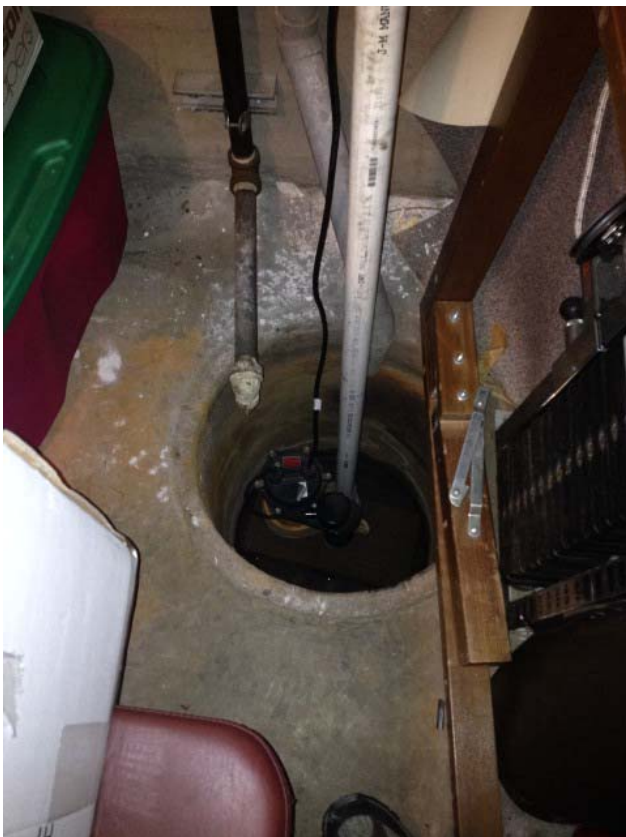
Photo 2.
View of sump and associated pump in basement of
single-story medical building.
Photograph taken on October 21, 2014.

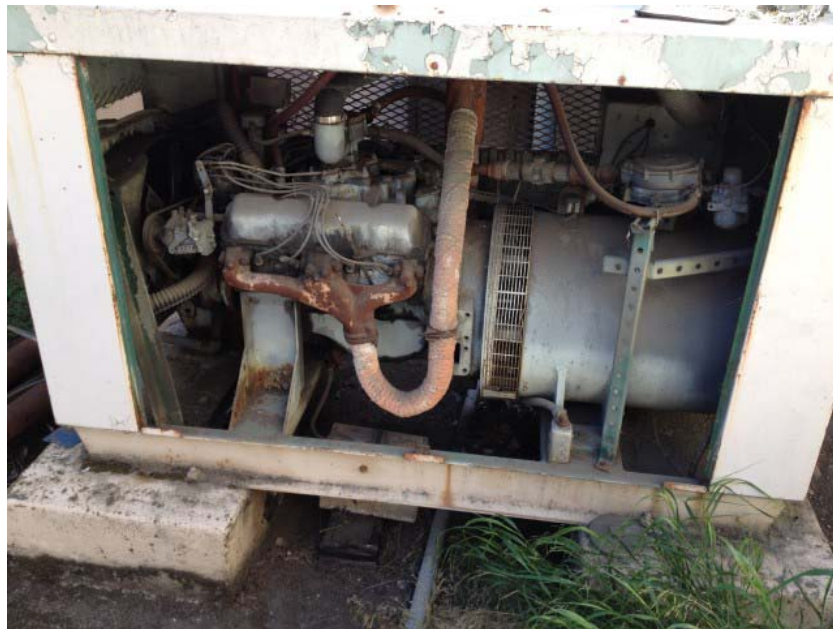
An internal combustion engine (ICE) generator was observed in an equipment courtyard located in the center of the subject property buildings (Plate 4, Photo 2; and Plate 19, Photo 2). A fuel source was not identified during the inspection, and Mr. Fukumoto was unaware of the historic or current fuel source. No records concerning the ICE generator were obtained by PES from local oversight agencies. The generator did not appear to be operable and no fuel source was identified.

Photo 2.
View of internal combustion powered generator located in interior courtyard of subject property. Photograph taken on October 21, 2014.

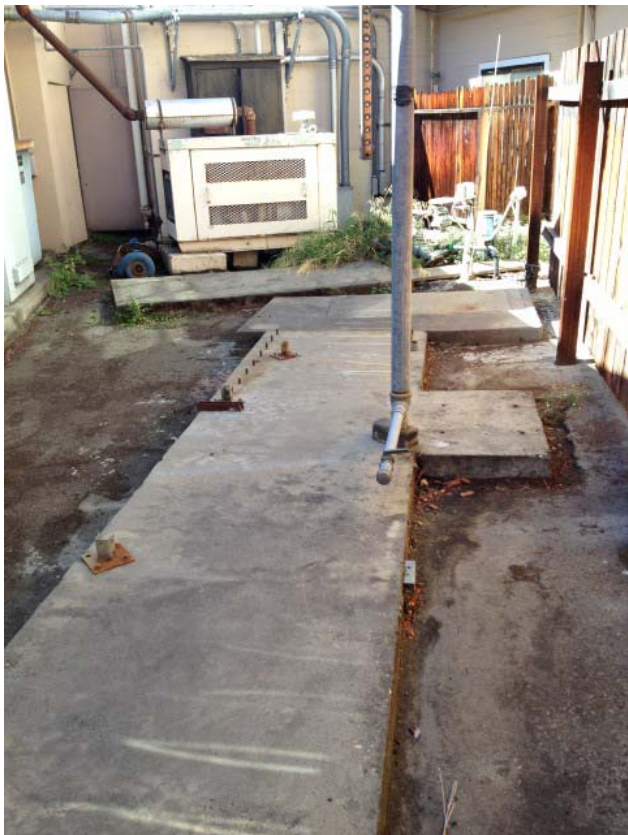
19

Photo 1.
View of courtyard area and internal combustion engine/generator.
Photograph taken on October 21, 2014.

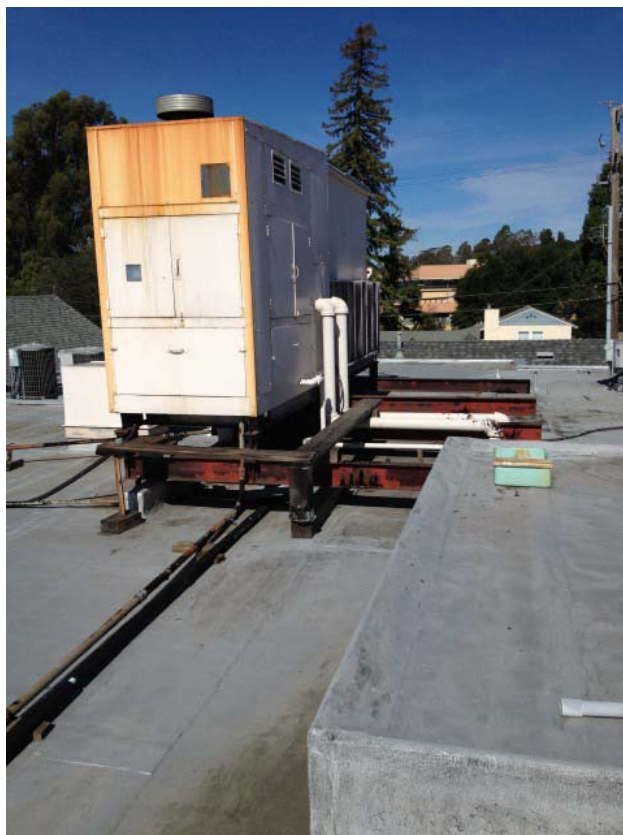
Photo 2.
View of refrigerant unit located on roof. Photograph
taken on October 21, 2014.

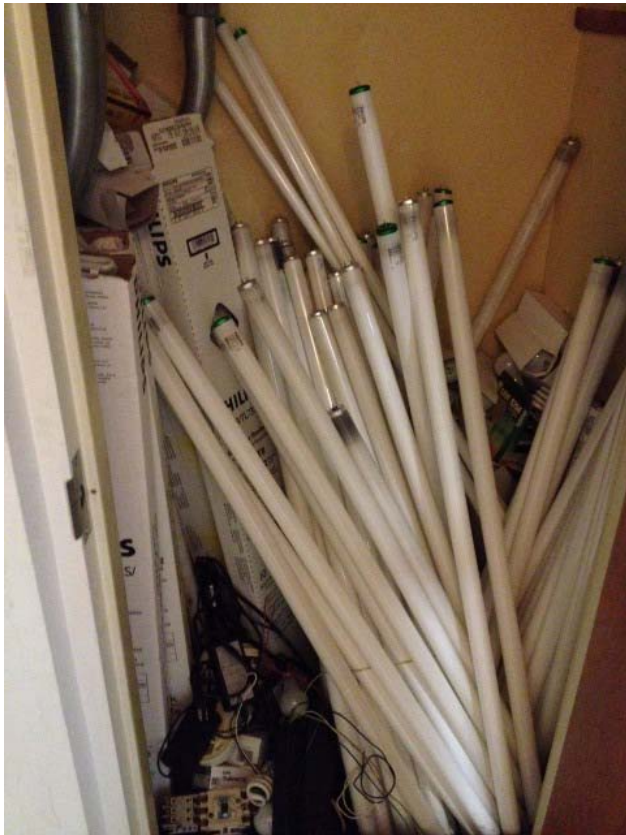
20

Photo 1.
Universal waste stored in basement-level closet. Photograph taken on October 21, 2014.

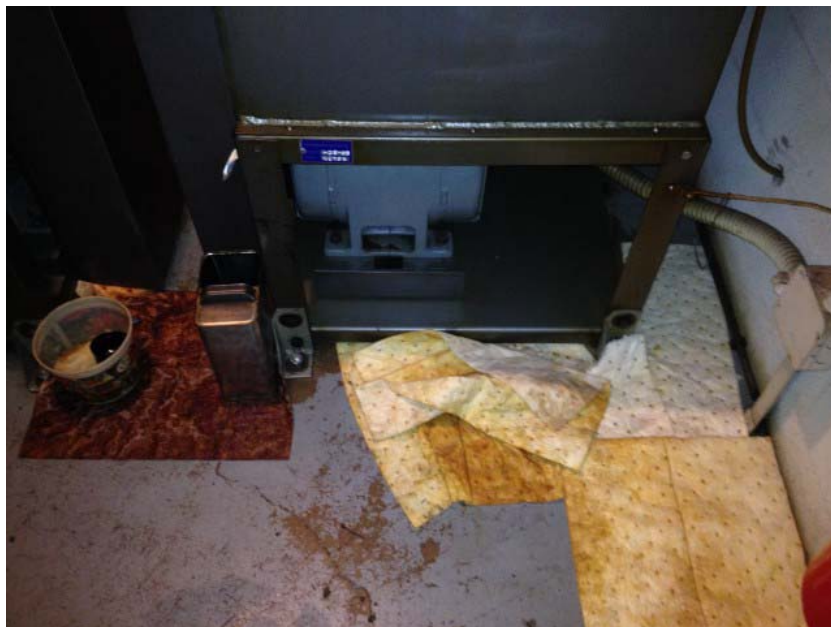
22

Photo 1.
View inside basement-level elevator machine room; absorbant pads, staining and leakage of hydraulic fluid apparent on concrete floor. Photograph taken on October 21, 2014.

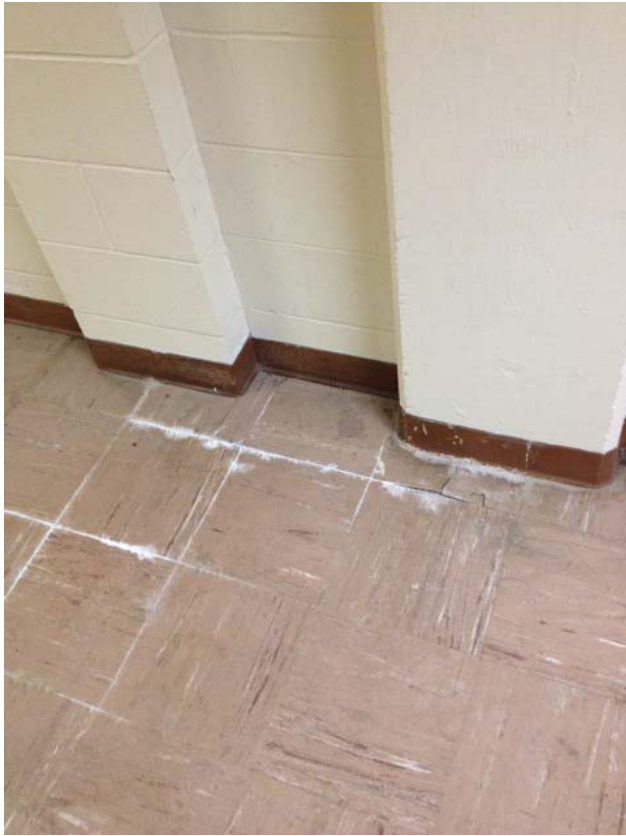
23

Photo 1.
View of possible water intrusion area in basement floor.
Photograph taken on October 21, 2014.

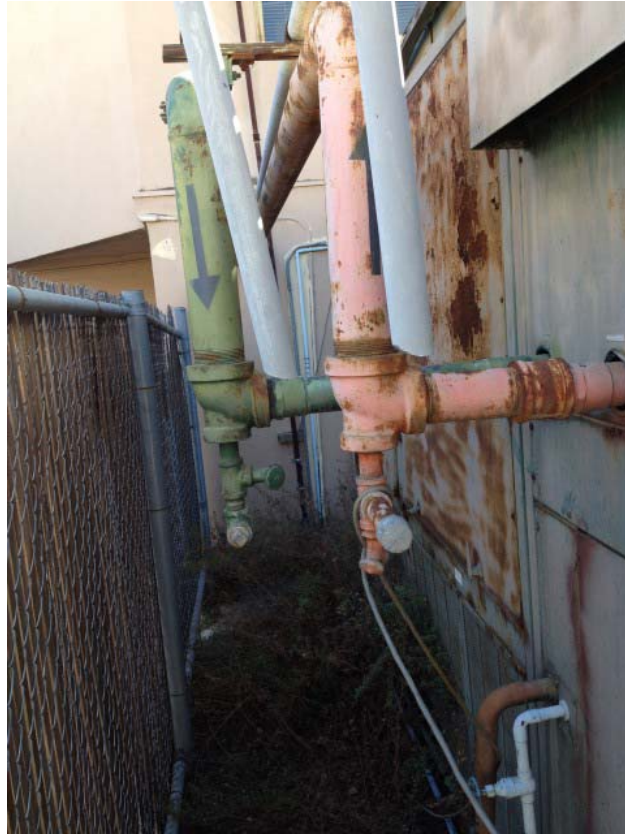
Photo 1.
View of natural gas-powered boiler located in backyard
of 1013 McKeever Avenue. Photograph taken on
October 21, 2014.
